Manhole Inspection Summary

Manhole # S21II_039MH

Insp Date: **3/4/09 9:40 AM**

Location Address: **N MOUNT ST**

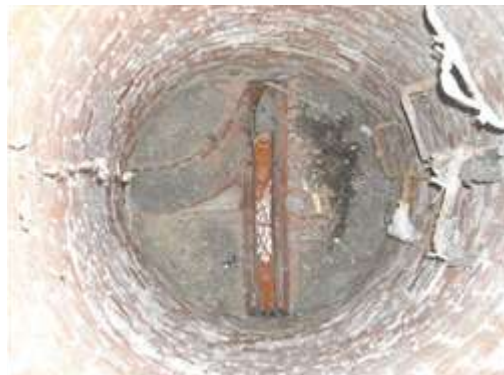
Top View

Comments **OBSERVED STUCK VENTED STORM DRAIN COVER. BROKE AND REPLACED LID WITH NEW 24" SANITARY LID BY REI/DRAYCO. INSPECTION COMPLETE.**

REPLACED OLD LID WITH NEW 24" SANITARY LID
